CASE STUDY

Gas Turbine Shaft Rub

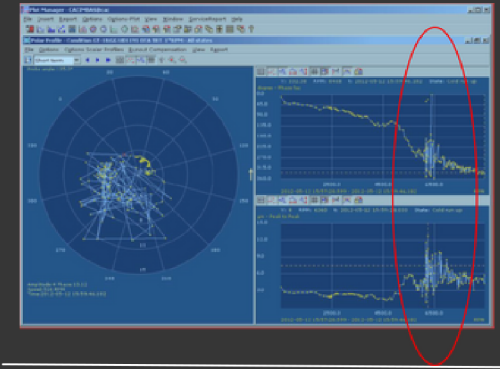
EtaPRO® Predictor™ AutoDiagnosis™ triggered while passing through critical speed; vibration within normal limits after start-up.

Inspection revealed improper coupling installation resulting in oil leak with coking increasing shaft profile.
