CASE STUDY

Gas Turbine Blade Damage

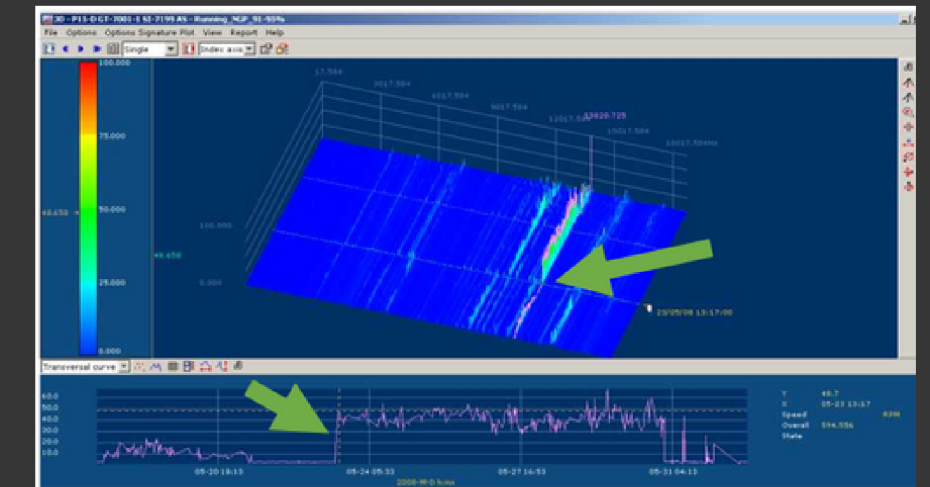
Compressor blade fault triggered instantaneous AutoDiagnosis™.

Step change in AS at 9th stage blade passing frequency, (13.8 KHz); overall vibration normal within normal limits.

Avoided potential collateral damage to nearby blades.
