# CASE STUDY

EtaPRO® Remote Monitoring & Diagnostics Center

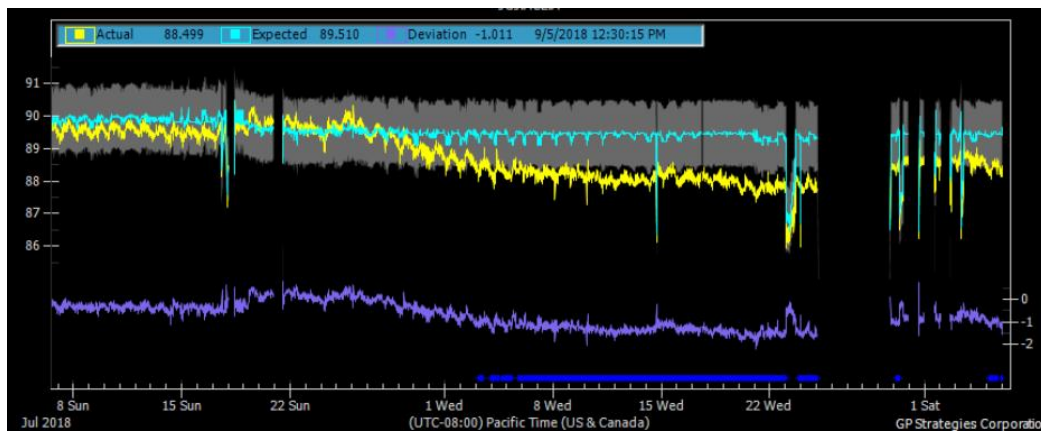
The EtaPRO M&D Center identified a drop in compressor efficiency on two gas turbine at a 2x1 Combined Cycle plant.

Since the drop compressor efficiency occurred on two separate machines around the same time, the issue was believed to be related to the intake. It was determined that wild fires in the area caused compressor fouling due to particulates in the air.

*EtaPRO APR trend of Reduced Compressor Efficiency*

Due to the advanced warning from the EtaPRO M&D Center, the plant was able to schedule compressor cleaning to recover gas turbine performance. An analysis of the gas turbine output and heat rate indicated that the 1.5% reduced compressor efficiency resulted in an additional 200 Btu/kWh heat rate and a capacity loss of 5 MW per gas turbine. Savings from are estimated at \$150,000.

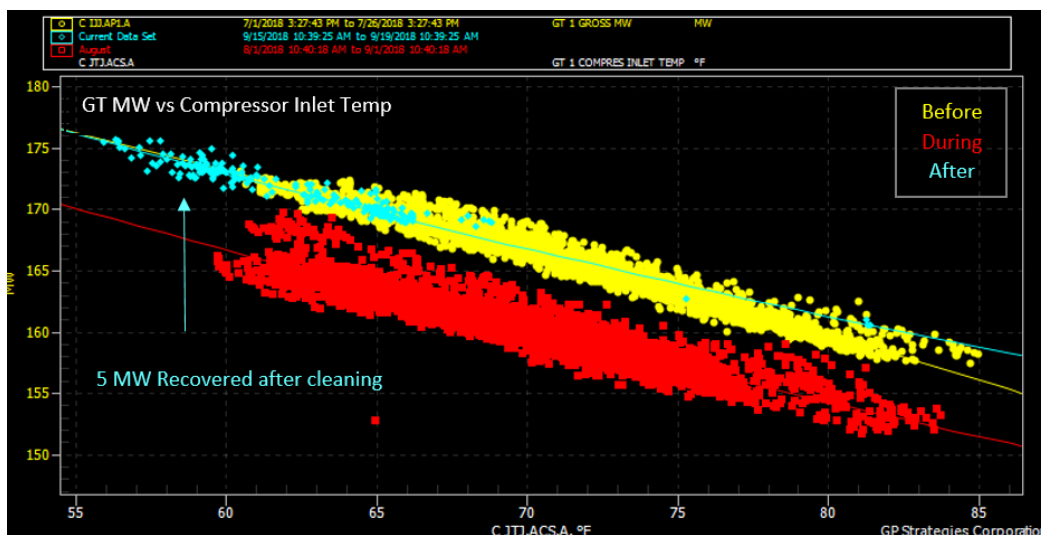
*EtaPRO Plot indicating Gas Turbine Output vs Compressor Inlet Temperature before, during and after the compressor-fouling event.*

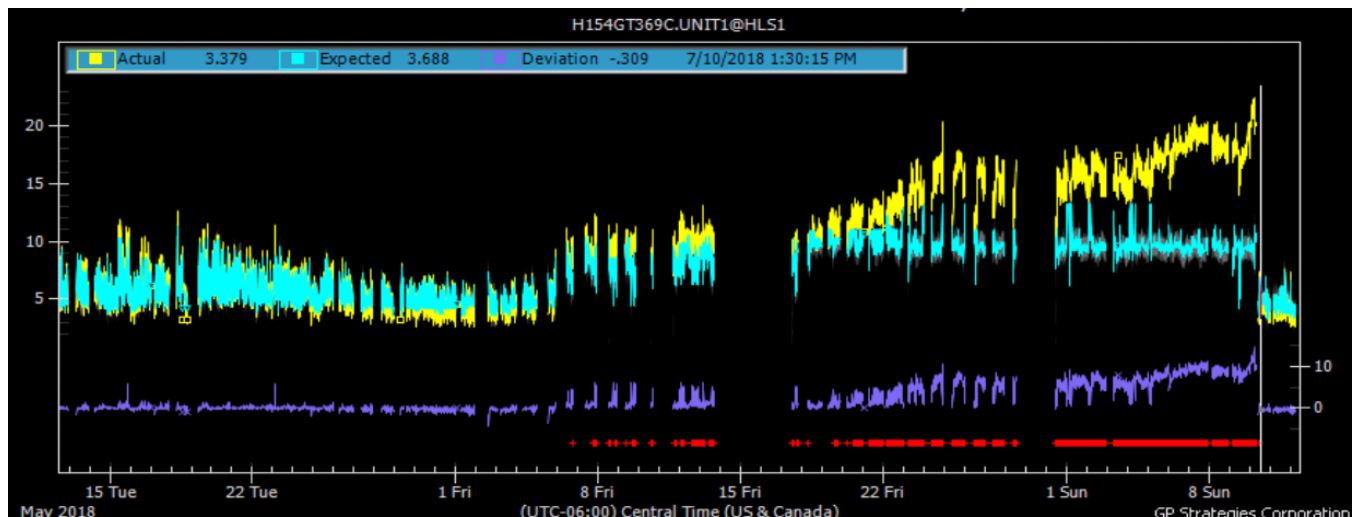
The EtaPRO M&D Center identified high vibrations on a SDA atomizer spindle vibration.

The atomizer was believed to have been plugging up resulting in elevated vibrations (a common issue with SDA atomizers). The initial APR warning came in three weeks before reached the DCS alarm limit.

*EtaPRO APR trend of Elevated SDA Atomizer Spindle Vibration and Return to Normal*

Due to the advanced warning from EtaPRO APR, the plant was able to prepare the spare atomizer for replacement two weeks in advance of the DCS warning. Once the new atomizer was put in place, the M&D team was able to confirm vibration levels have returned to normal. Savings from are estimated at \$5,000.

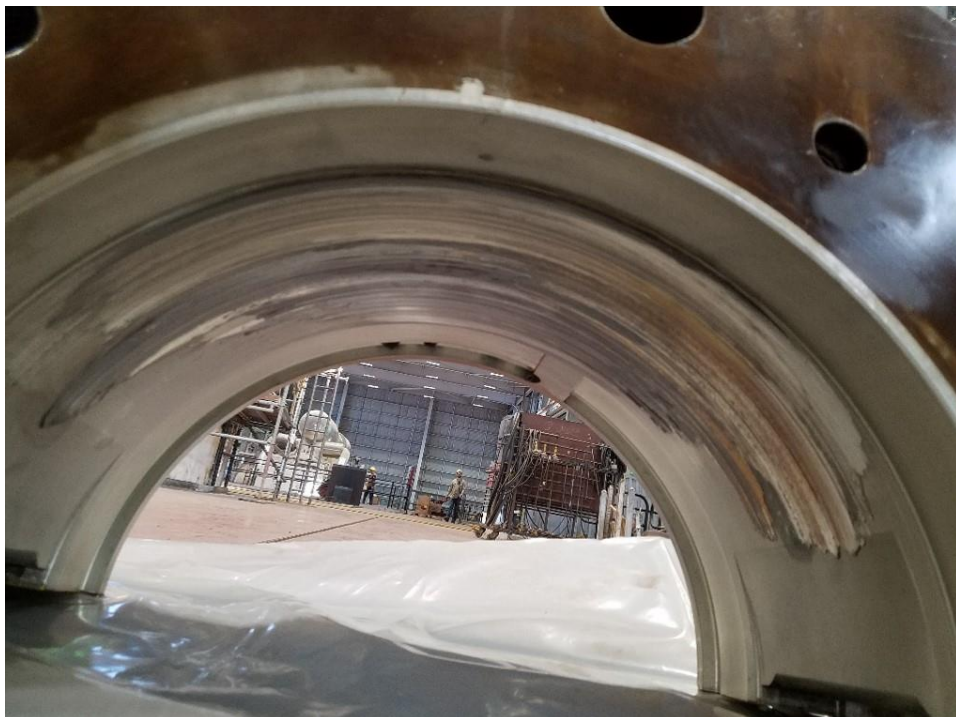
After inspection, the plant identified the damage to the upper bearing housing.

Damage found on steam turbine journal bearing. Conditions indicate rub occurred.

The plant was able to prepare and replace the journal bearing before any major damage occurred to the shaft or other components. This was able to be completed on a planned rather than an emergency shutdown or plant trip. The estimated savings from potential damage that was avoided is \$150,000.

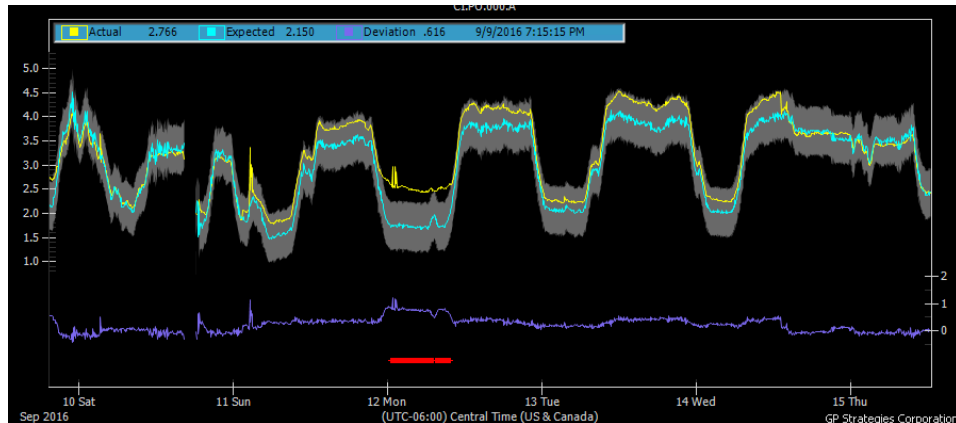
Early in the morning, the condenser cooling water outlet temperature CW-1 indicated a 10°F temperature shift. At the same time, the CW pump discharge pressure indicated a pressure increase of 5 psig. The condenser pressure did not show much movement at the time, but did rise early in the morning the following day and he remained 0.2-0.5 in Hga higher across the load range. The EtaPRO M&D Center made the recommendation to check the cooling water side for any obstructions.

After an inspection, the plant identified an issue with the cooling water inlet valve. The keyway was slipping off the shaft and not allowing the valve to open all the way. The issue was resolved within 36 hours of the initial alert from APR.

The elevated condenser pressure was resulting in a higher heat rate and reduced capacity. Losses were estimated at \$38,000 per month.

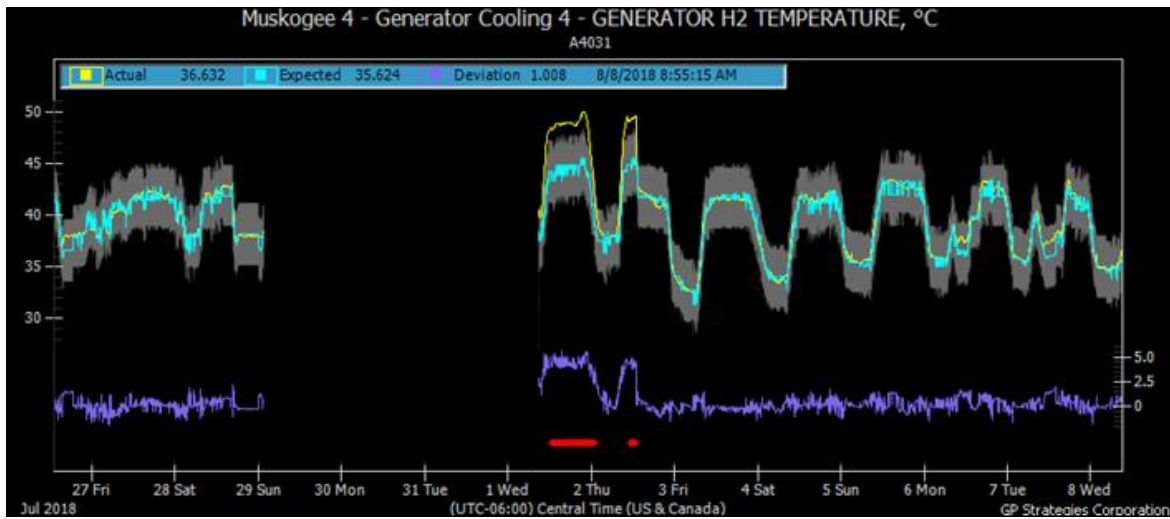
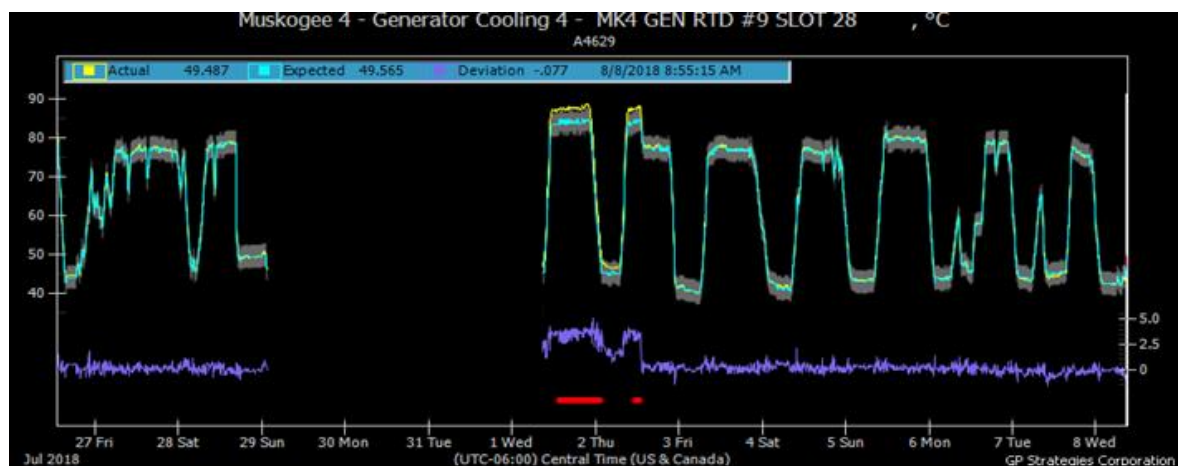
The EtaPRO M&D Center team identified a hydrogen temperature increase of 5°C on a steam turbine generator. A similar increase was also found on multiple generator stator slot temperatures.

After inspection, the hydrogen cooler was determined to be air bound. The plant burped the hydrogen cooler to remove air in the system and the temperatures returned to normal.

The issue was identified, diagnosed and resolved in less than 24 hours before temperature elevated to an alarming range. This prevented additional wear from elevated temperatures and potentially avoiding a unit trip had the issue gone unnoticed.
